28 Die in Pioneer Hotel, Tucson, Arizona

LAURENCE D. WATROUS

Supervisor, NFPA Fire Record Department

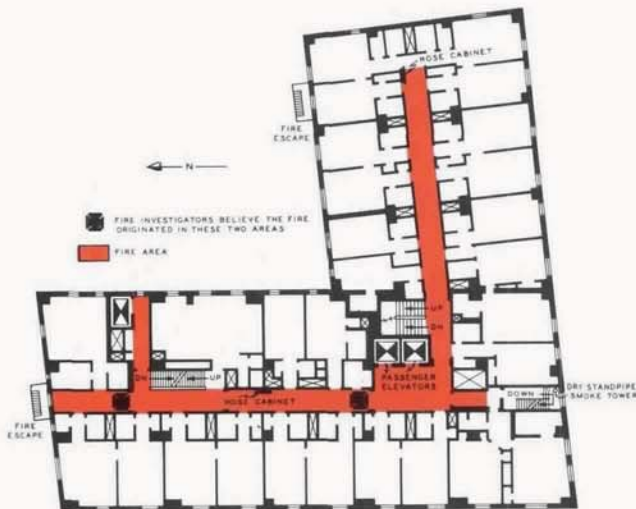
Figure 2. Floor plan of the fourth floor, which is typical of the third through sixth stories. The shading indicates the area on the fourth floor destroyed by fire.

INVESTIGATIONS BY THE FIRE DEPARTMENT FIRE PREVENTION DIVISION found that two fires had started at two locations on the fourth floor of the main section, separated by about 60 feet. Officials believe the fires originated at floor level against the wall, where the floor carpet met the wall carpet. They feel the fires were set sometime before midnight and that they spread rapidly, joining and then spreading up the two open stairways. Lack of sufficient air allowed incomplete combustion to generate large quantities of fire gases and thick smoke. During the early stages, before the fire had taken control of the upper corridors, very few people were able to make their way to safety by way of the stairs and elevators. The fire quickly cut off the means of egress — the corridors. Very few people became aware of the fire in time, as there was no alarm system. Only those who smelled smoke or heard cries of fire in time were able to escape unaided. Several occupants made bed-sheet ropes to escape from their rooms. Several others shinned down electrical conduit attached to the rear of the building and adjacent to their windows as smoke entered around the doors and filled their rooms. Others threw mattresses to roofs below and jumped, some receiving injuries. Most of the occupants were rescued over Fire Department ladders.

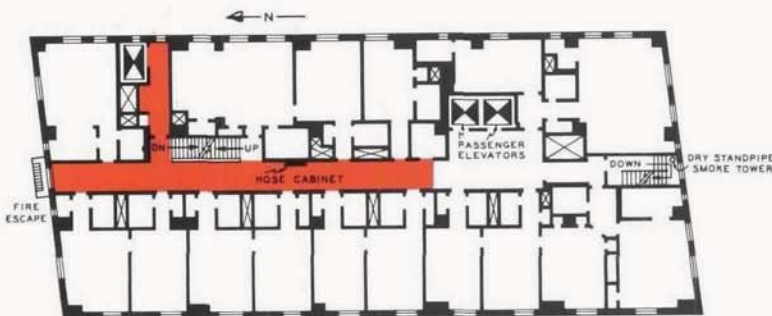
Figure 3. Floor plan of the tenth floor, which is typical of the seventh through eleventh stories. The shading indicates the area on the tenth floor destroyed by fire.

When all the information had been gathered the reports told a grim story about a fire-resistive building. Twenty-eight occupants had died; 38 occupants and 33 fire fighters had received injuries that required medical attention; and a loss estimated at \$1,500,000 had occurred. The fire had severely damaged the corridors and stairways from the fourth through the eleventh story, and six rooms had been burned out. Heat and smoke had caused varying amounts of damage in the other rooms.

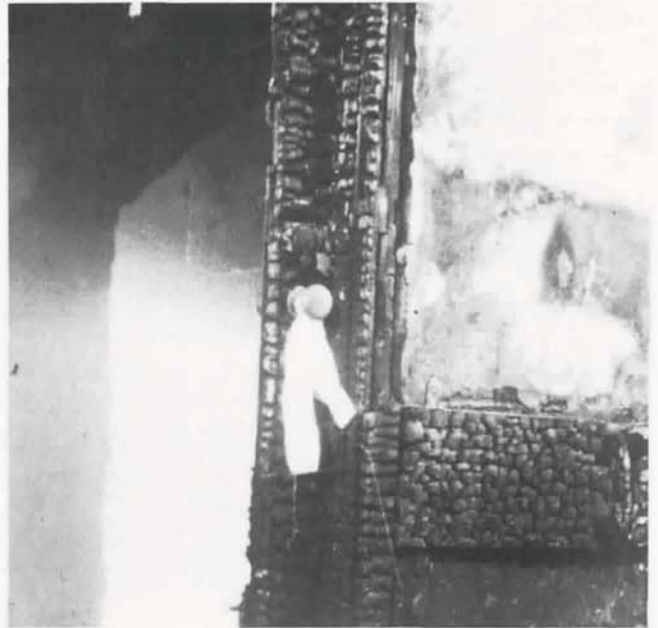
White rag still attached to doorway to indicate that the room had been searched. Such a procedure is an excellent idea during large search and rescue operations.

occupants on the eighth floor and five on the ninth floor. Three people on the eighth floor and one on the ninth floor died as the result of falls. To prevent confusion over which rooms had been searched, white rags were attached to the doorway of each room after it had been checked. Small hot spots were cooled down during and after the search. All men and apparatus had been returned to service by 8:00 am except one company, which remained as a fire watch until 3:00 pm.

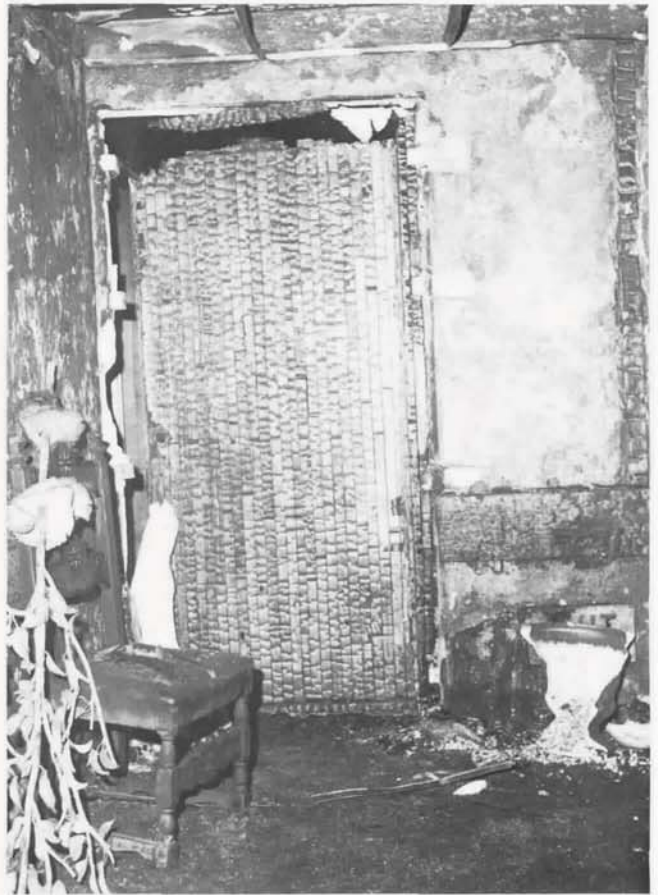
The side of a solid-core door that was exposed to the fire. Stairs are located just to the right behind the photographer.

Although a solid-core door on the eleventh floor at the top of the stairs withstood the force of the fire, it had not been installed properly. The door was too small for the opening in the tile wall and wood had been installed around it to make it fit. This wood around the door burned off and allowed the fire into a void space in the wall above the door. Heat and smoke filled the rooms behind this door, killing the occupants. The two permanent residents who occupied the area had been living in the building since it opened. It is ironic that they died, because there was a fire escape within several feet of where their bodies were found. Several years ago the window to the fire escape had been covered over with a canvas sheet painted the same color as the wall. A light drape had been hung to cover this part of the wall.

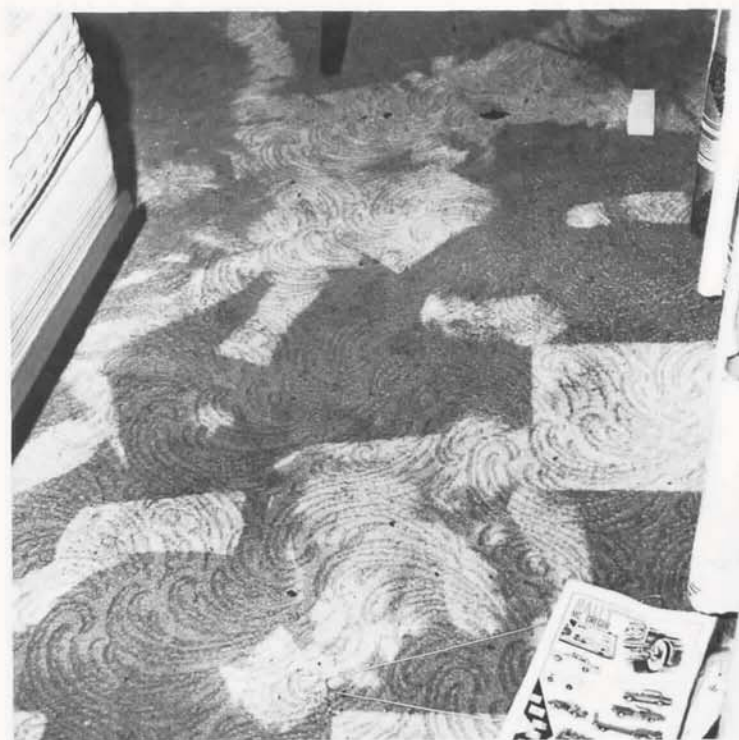
The outlines of two young boys who died of carbon monoxide poisoning. Tucson Daily Citizen

About an hour after the initial alarm the fire was considered under control, and a search for victims was begun. Carbon monoxide had killed two occupants in the sixth story, two in the seventh, one in the ninth, six in the tenth, and six in the eleventh. Burns killed two

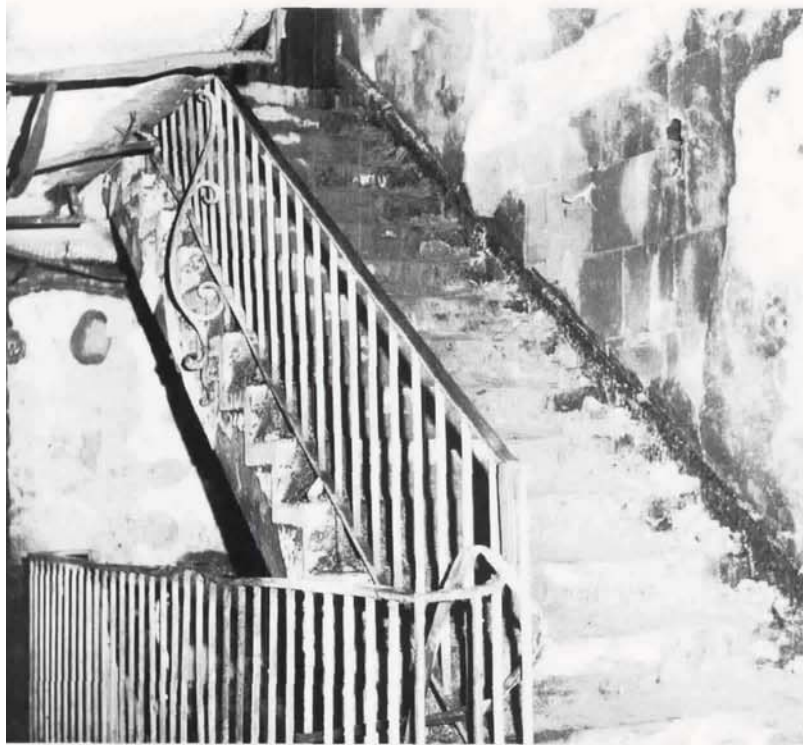
Top: The stairway from the fifth to the sixth floor. Note how the heat bent the railing and spalled the plaster covering the tile wall.

IT IS VERY DIFFICULT to protect a building from arson fires. However, once the fire is started there should be ways of slowing its progress. Closed fire doors on enclosed stairways would have greatly limited the vertical spread of heat and fire gases. While the fire originated on the fourth floor and spread through all the corridors to the roof, only rooms on the sixth, eighth, and ninth floors were severely damaged by fire. The occupants who died were located on the sixth through the elev-

enth floor. Enclosed stairways and closed fire doors would probably have held the fire to one floor.

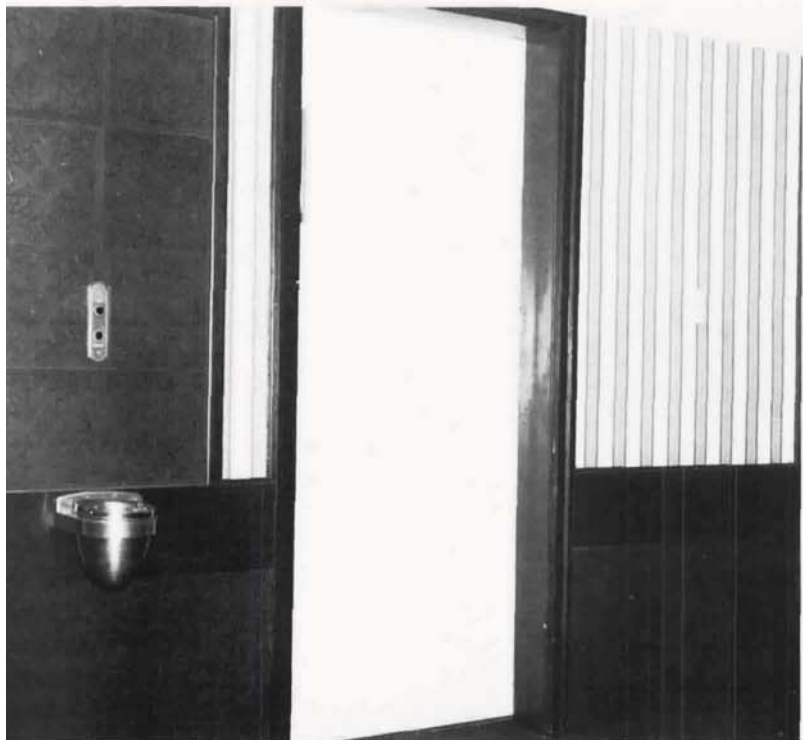
Above: The third-floor elevator lobby. Note the carpeting, the eight-inch strip of laminated plywood, and the plastic wall covering. All the elevator lobbies were alike.

The walls, ceiling, and floors of the corridors were of masonry or plaster construction and, therefore, did not contribute to the fire load. The carpet and the wall covering did, however, and to a degree sufficient to cause the fatalities and the severe damage.

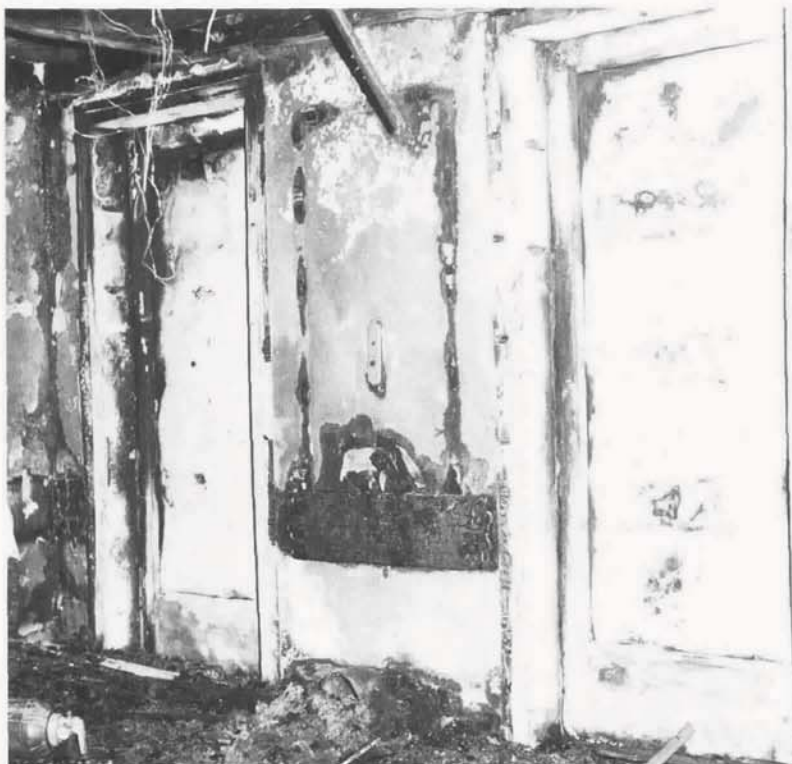
Top: The fifth-floor elevator lobby after the fire. The interiors of the doors were discolored but no fire passed into the shaft.

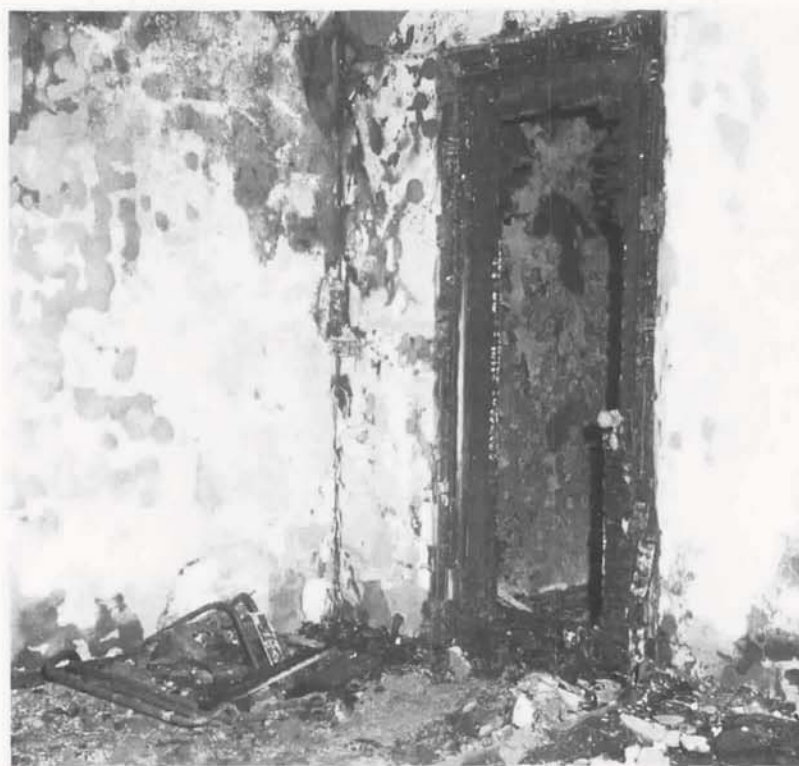
The light panel doors held up fairly well and did not allow a significant amount of fire into the rooms, even though there was severe burning in the corridors. The rooms in which the doors had been opened and left open were completely burned out by superheated fire gases that burned viciously when mixed with the fresh air in the rooms.

Above: This room is on the eighth floor. The door to the corridor was left open during the fire.
